Sample Pre-drywall Inspection Report

Property address: **1234 Lake Dr.
Cumming, Ga. 30041**

Inspection date: **Thursday, October 31, 2013**

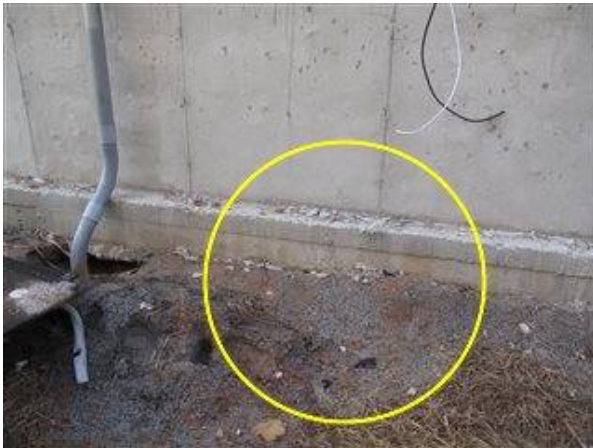
Photo 61

One or more footings were undermined by excavation, erosion. The footing and foundation has been weakened as a result. Repairs should be made as necessary.

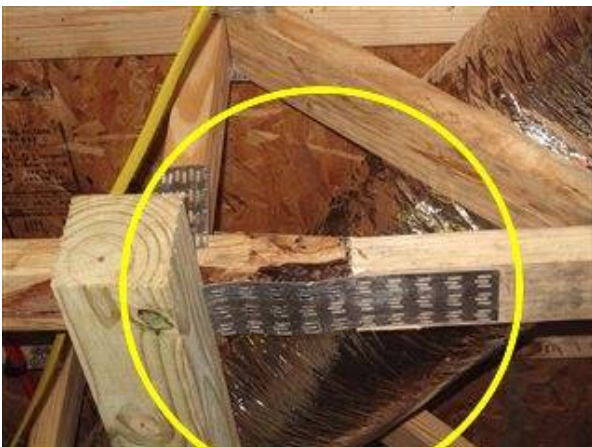
Photo 32

3) 🔍 One or more engineered floor joists, floor trusses, glue lams or structural composite lumber appeared to have been cut, damaged or modified. The floor structure has likely been weakened as a result. These components should only be modified by registered design professionals. Consult with the builder to determine if modifications were approved. If not then modified components should be replaced.

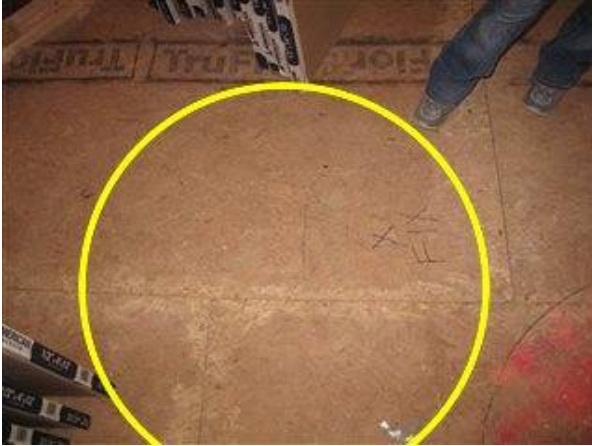
Photo 28

4) 🔍 One or more floors were uneven, damaged, or not level. This can result in problems

when installing other components such as cabinets, tubs, showers, trim, flooring etc. Repairs should be made as necessary.

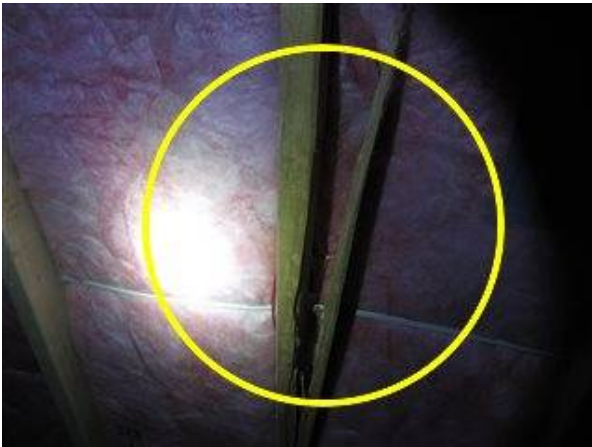
Photo 55

One or more studs were split, damaged, or excessively warped. This can result in bowed or uneven walls, and problems when installing other components such as cabinets, tubs, showers, trim, etc. Repairs should be made as necessary.

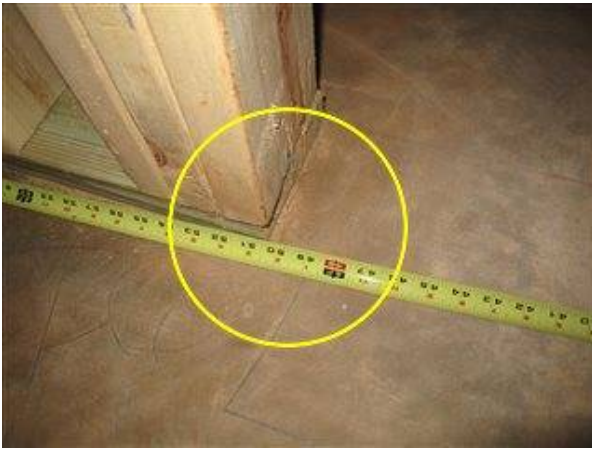
Photo 71

Wall openings at one or more locations were not square. This can result in problems when installing other components such trim and doors, etc. Repairs should be made as necessary.

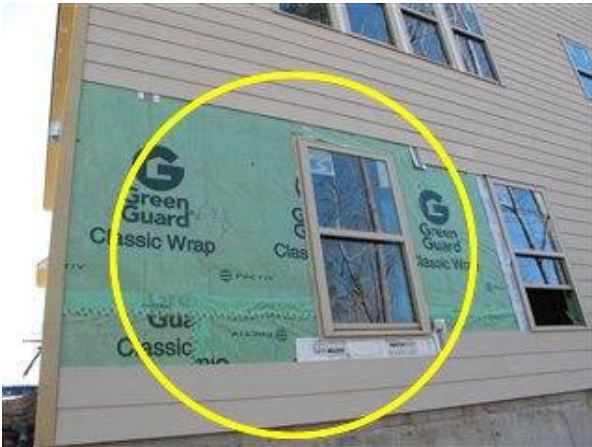
Photo 63

One or more sections of siding were missing. This can be a conducive condition for wood destroying organisms. Repairs should be made as necessary.

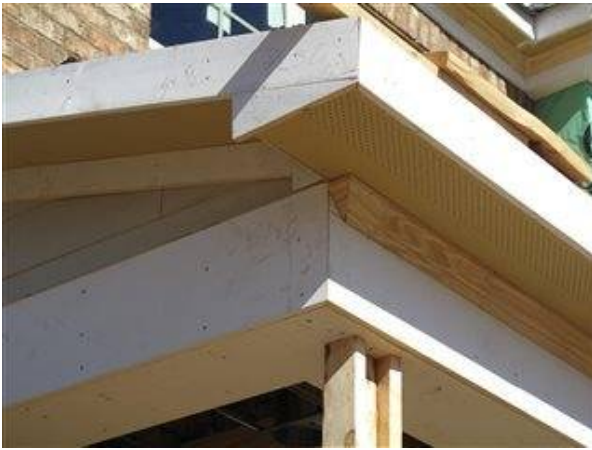
Photo 64

Some areas of the exterior paint or stain finish were incomplete and/or substandard (e.g. primed only, too few coats). Paint or stain should be applied where necessary.

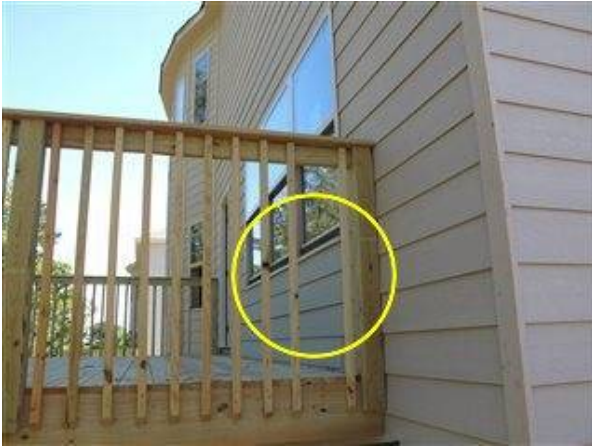
Photo 17

Guardrails at one or more locations had gaps that were too large. Gaps or voids should not allow passage of a sphere equal to or greater than 4 inches in diameter, or 6 inches in diameter at triangular spaces between stair edges and guardrails. This can pose a fall hazard. Repairs should be made as necessary.

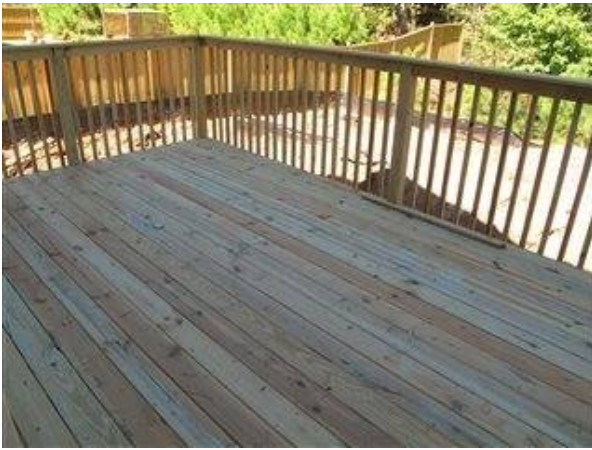
Photo 31

Wooden deck or porch surfaces will require an application of a stain, or sealant in the future as part of normal maintenance. Recommend that a qualified person clean and preserve as necessary once the wood has seasoned. We recommend using the "cup-of-water" test before staining. Take a cup of water and pour it onto the treated lumber in several places. If the water is absorbed and doesn't bead up, the lumber is ready for painting or staining.

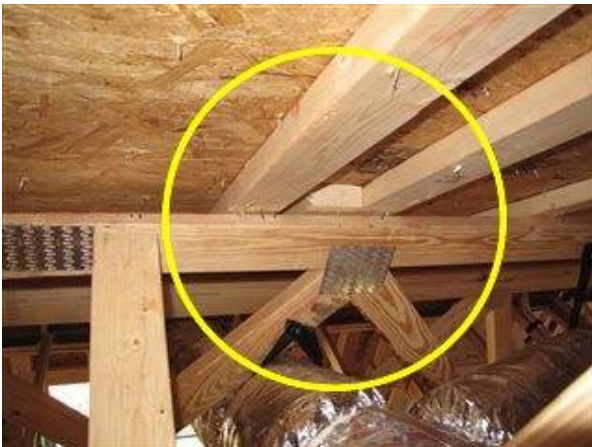
Photo 69

One or more roof trusses or engineered joists or rafters were improperly nailed. The roof decking is buckling or lifting as a result. Repairs should be made as necessary to properly secure the roof decking and allow the composition shingles to seal properly.

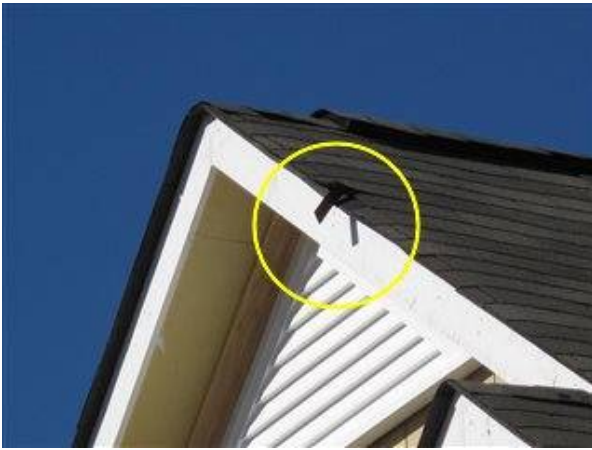
Photo 65

The roof surface installation was not complete. It should be complete to prevent water damage before drywall is installed. Repairs should be made as necessary.

NOTE (One or more 2x4s "toe boards" were nailed on top of the shingles to give the roofer support on steep pitches. Once these boards are removed the shingles will require repair to prevent water damage in the future to the decking and ceiling areas below).

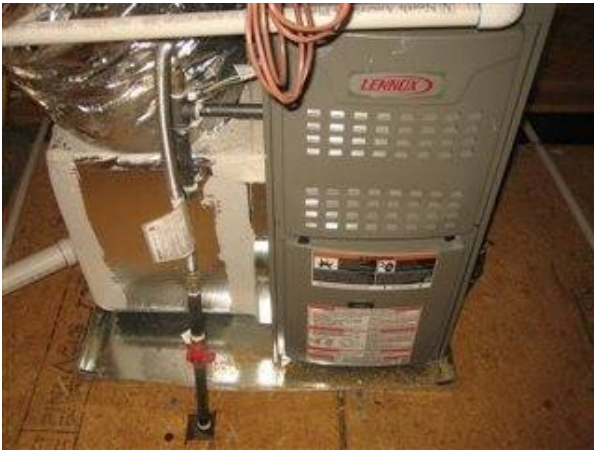
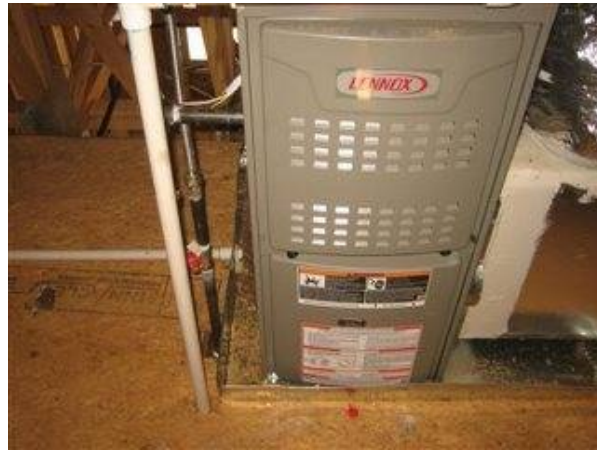
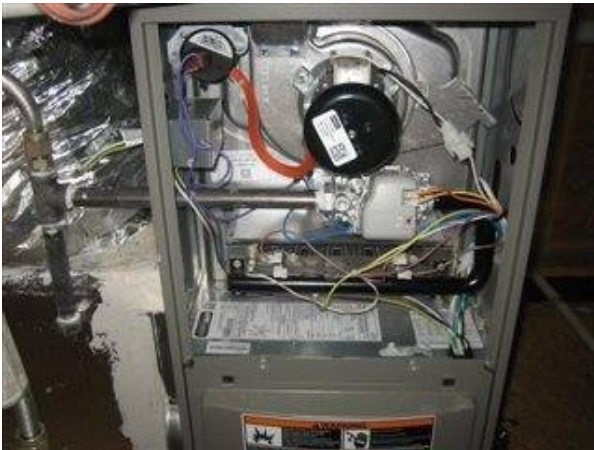
The furnace and/or heating systems were not fully evaluated because the installations are incomplete. Recommend that a full evaluation be made by a qualified person when conditions have been corrected so the systems are operable.

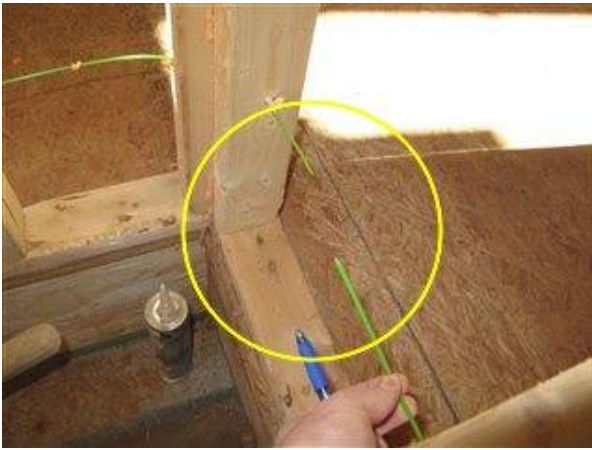
Photo 62

One or more sections of the Taexx through the wall pest control system installed in this home are cut or damaged. Repairs should be made as necessary.

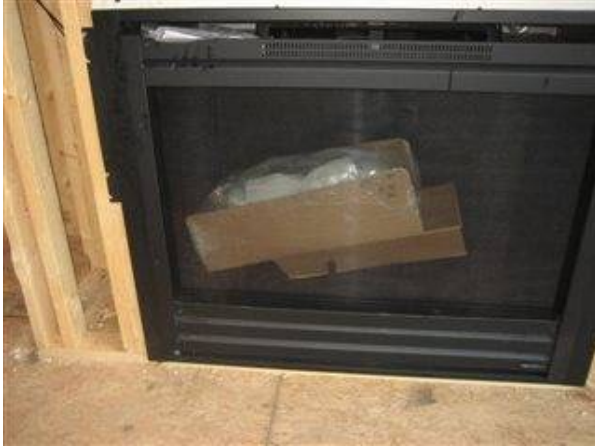
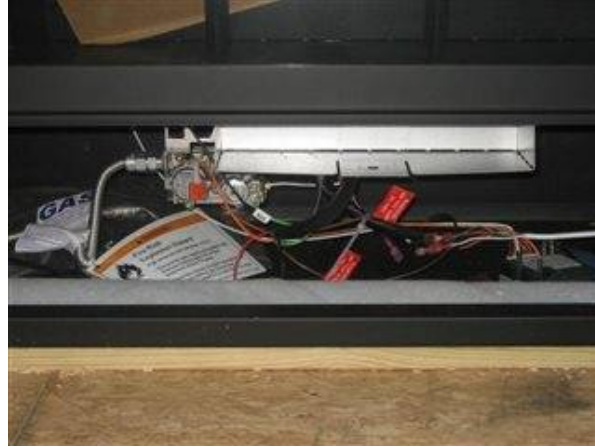
17) **i** The inspector was unable to determine if the gas fireplace or stove was operable or serviceable, or perform a full evaluation as the installation was incomplete.

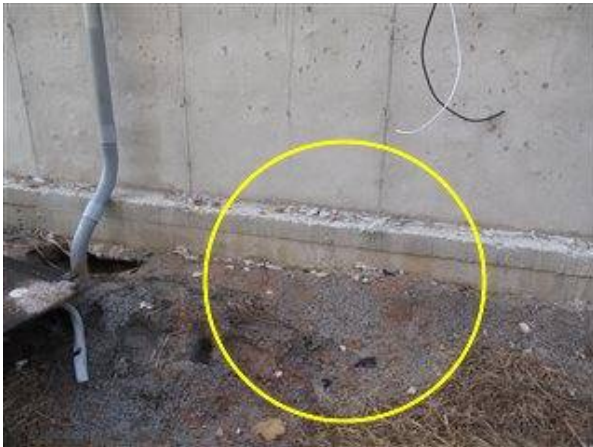
Photo 61

- One or more footings were undermined by excavation, erosion. The footing and foundation has been weakened as a result. Repairs should be made as necessary.

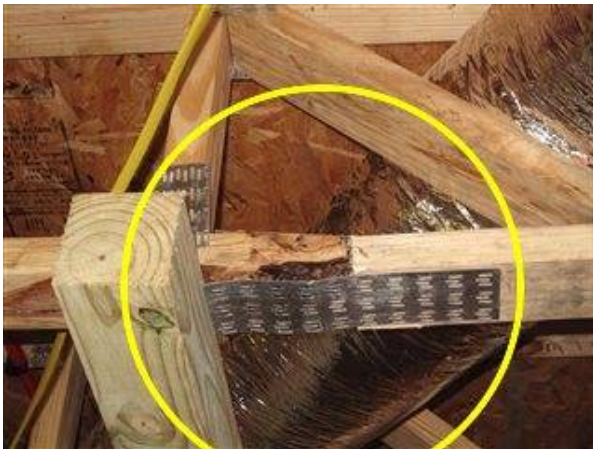
Photo 32

- One or more engineered floor joists, floor trusses, glue lams or structural composite lumber appeared to have been cut, damaged or modified. The floor structure has likely been weakened as a result. These components should only be modified by registered design professionals. Consult with the builder to determine if modifications were approved. If not then modified components should be replaced.

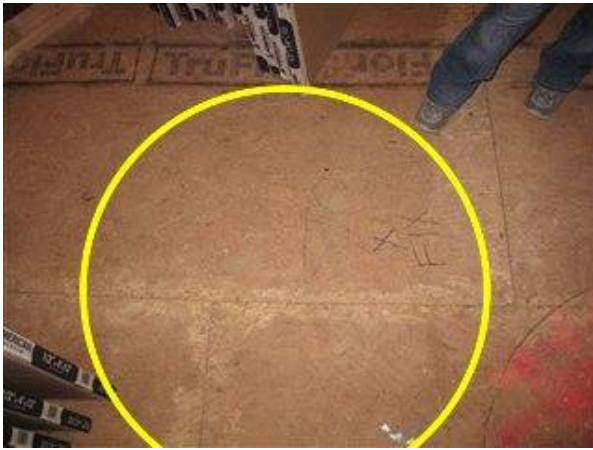
Photo 28

- One or more floors were uneven, damaged, or not level. This can result in problems when installing other components such as cabinets, tubs, showers, trim, flooring etc. Repairs should be made as necessary.

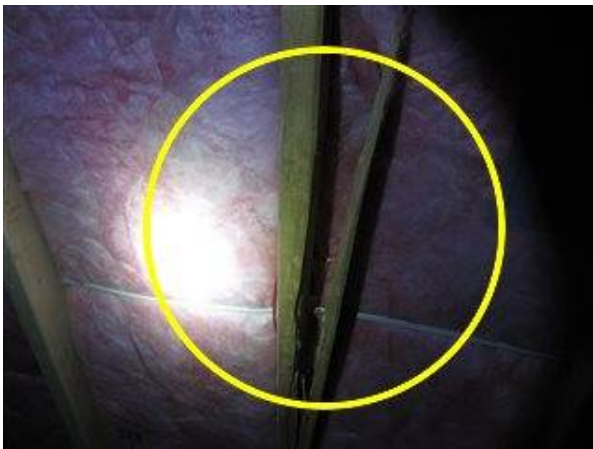
Photo 55

- One or more studs were split, damaged, or excessively warped. This can result in bowed or uneven walls, and problems when installing other components such as cabinets, tubs, showers, trim, etc. Repairs should be made as necessary.

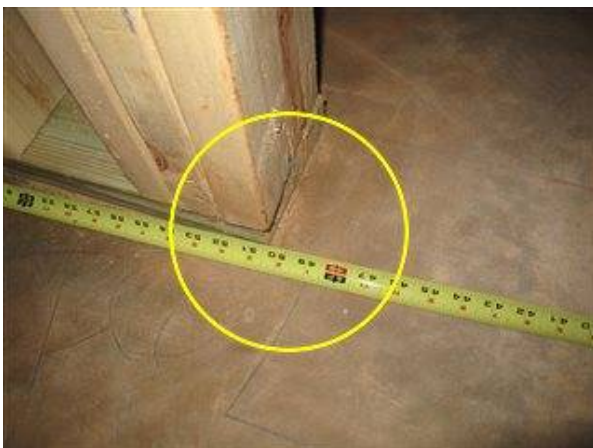
Photo 71

- Wall openings at one or more locations were not square. This can result in problems when installing other components such as trim and doors, etc. Repairs should be made as necessary.

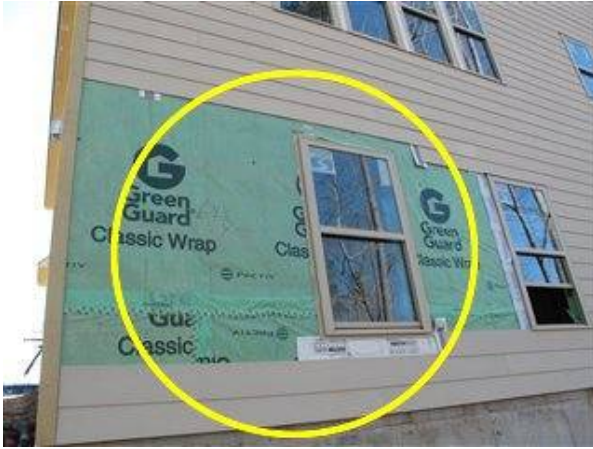
Photo 63

7) 🛠️💧 - One or more sections of siding were missing. This can be a conducive condition for wood destroying organisms. Repairs should be made as necessary.

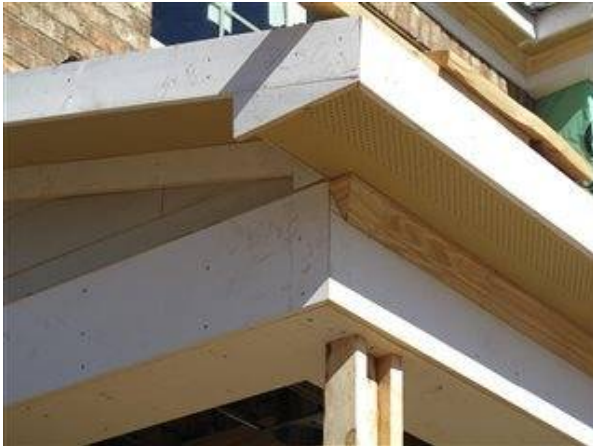
Photo 64

8) 🛠️ - Some areas of the exterior paint or stain finish were incomplete and/or substandard (e.g. primed only, too few coats). Paint or stain should be applied where necessary.

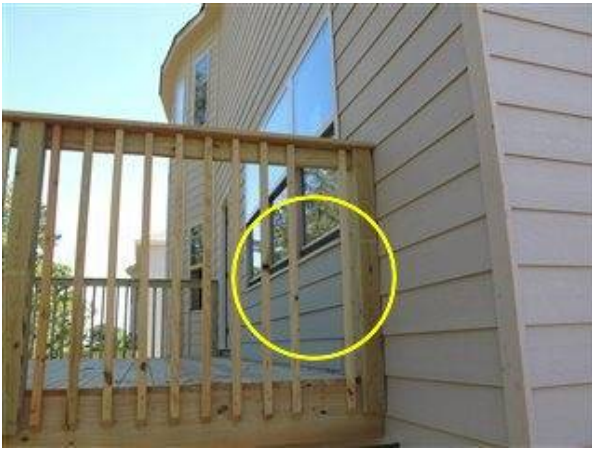
Photo 17

9) 🛠️🚶 - Guardrails at one or more locations had gaps that were too large. Gaps or voids should not allow passage of a sphere equal to or greater than 4 inches in diameter, or 6 inches in diameter at triangular spaces between stair edges and guardrails. This can pose a fall hazard. Repairs should be made as necessary.

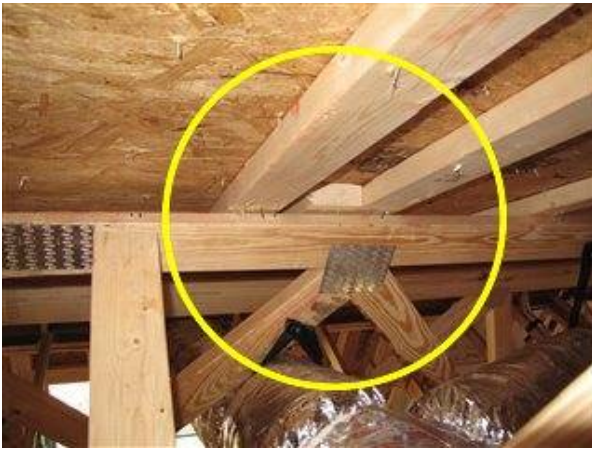
Photo 69

11) 🔧🔍 - One or more roof trusses or engineered joists or rafters were improperly nailed. The roof decking is buckling or lifting as a result. Repairs should be made as necessary to properly secure the roof decking and allow the composition shingles to seal properly.

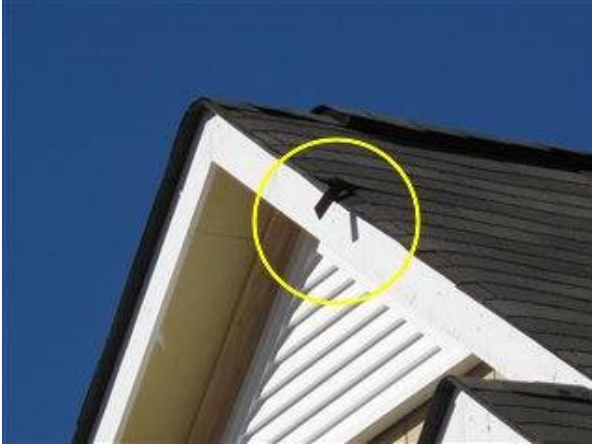
Photo 65

12) 🛠️ - The roof surface installation was not complete. It should be complete to prevent water damage before drywall is installed. Repairs should be made as necessary.

NOTE (One or more 2x4s "toe boards" were nailed on top of the shingles to give the roofer support on steep pitches. Once these boards are removed the shingles will require repair to prevent water damage in the future to the decking and ceiling areas below).

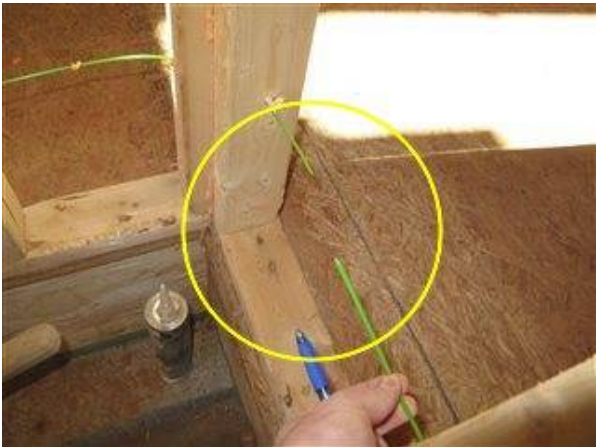
Photo 62

14) 🛠️ - One or more sections of the Taexx through the wall pest control system installed in this home are cut or damaged. Repairs should be made as necessary.
